CASE STUDY

Peldon Rose , 20, St Dunstons' Hill London – Removal Contract

Type of work: Removal of Asbestos Insulating Board, approximately 750m², from high level plant room roof structures.

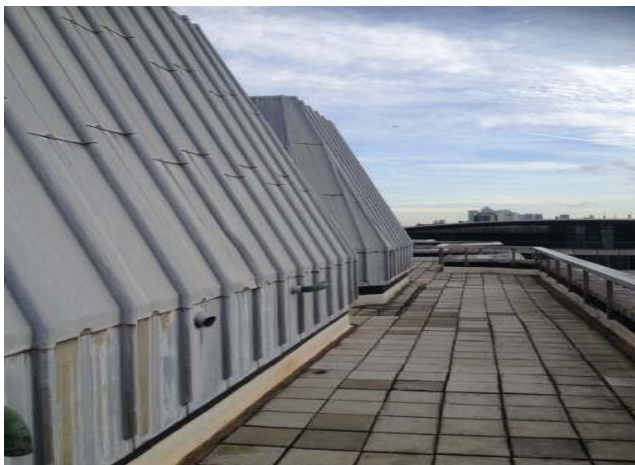
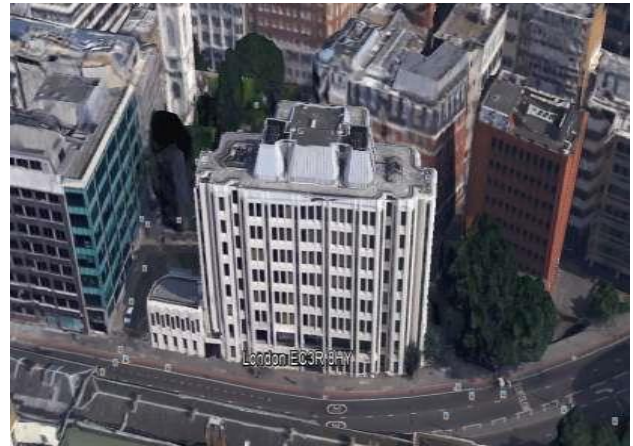
The project required the removal of the AIB roof structure covering 2 x Plant rooms on the roof level of the building. The AIB was currently covered by hessian sheet which , in turn, was covered by lead sheeting. The Client required the lead sheeting to be removed, cleaned and returned to the client project team either for re-use for its' significant scrap value.

- (1) The asbestos work was within 5 metres high plant room structures on the roof area of the building which was approx.30 metres plus in height. Full cover scaffold & sheeting was required so that the work areas were completely enclosed. Weather conditions had to be considered, particularly wind, in constructing a fit for purpose and safe overall scaffold cover.

- (3) The existing lead covering to the plant rooms was removed, carefully cleaned off by hand and returned to the client team. Care had to be taken during the removal of the lead sheets due to possible damage and their weight as each panel had to be lowered manually to the roof area for the onward cleaning task to be effected.
