## Banqueting House, Whitehall

Client: Historic Royal Palaces

Type of work: Removal of asbestos contaminated waste from roof floor void and ceiling decorations, Phase 1 Refurbishment Programme

## Phase 1 Refurbishment Programme

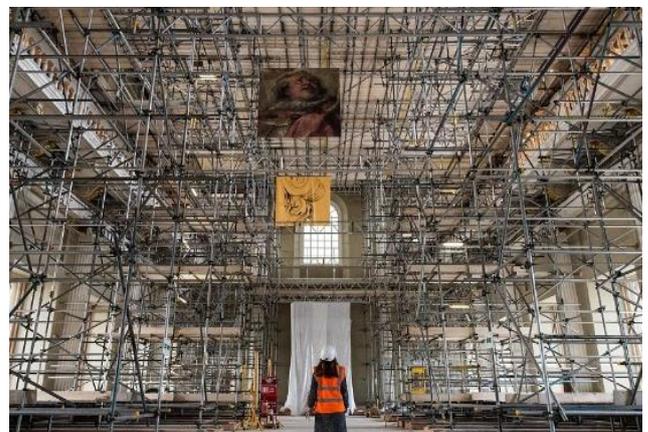
### Access Scaffolding

The access scaffolding inside Banqueting Hall indicates the height of the hall and the scale of the project. Specialist scaffolders took three weeks to erect the scaffolding.
